**COMPARISON TESTING IN A SIMULATED DATA PROCESSING/  
TELECOMMUNICATIONS FACILITY:  
FM-200<sup>®</sup> AND AUTOMATIC SPRINKLER SYSTEMS**

Mark L. Robin and Eric W. Forssell  
Hughes Associates, Inc.  
5415 Hillside Lane  
West Lafayette, IN 47906  
Ph: 765-583-0718; Fax: 765-583-2066  
mrobin@haifire.com

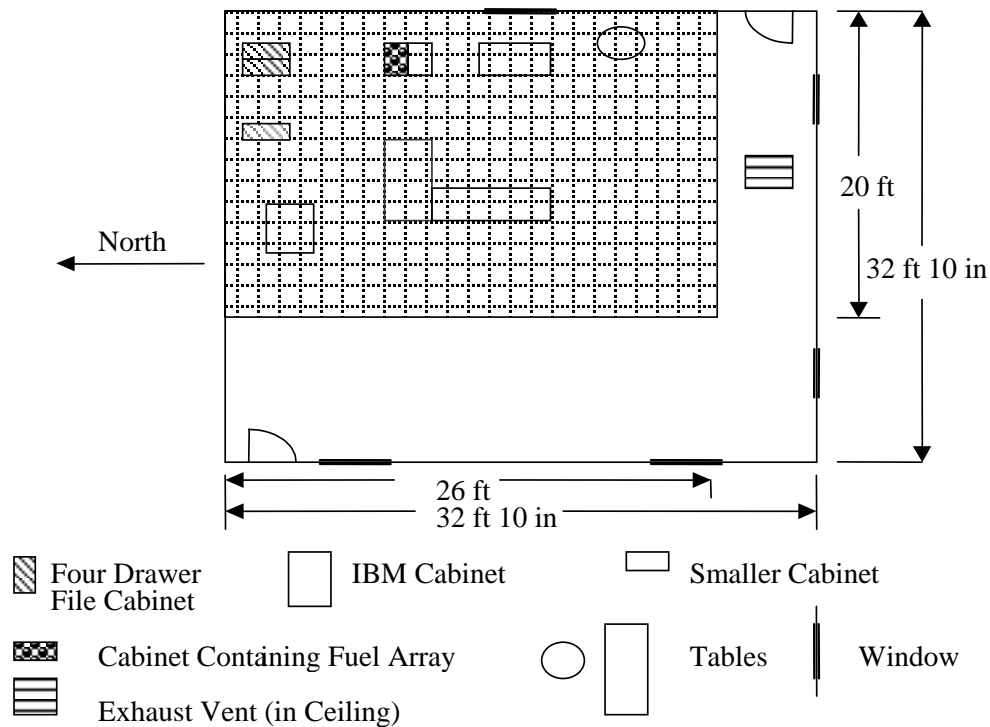
**Figure 1. Test Enclosure**

The test enclosure is shown schematically in Figure 1. The test enclosure was designed, constructed and outfitted to simulate a typical data processing or telecommunications facility. The tests were performed in a 32.8 ft x 32.8 ft x 12 ft enclosure equipped with a 1.5 ft deep subfloor and a suspended ceiling located 2 ft below the drywall ceiling. The chamber was constructed from 0.5 inch gypsum wallboard over a metal stud frame. Access to the room is accomplished via two 2.9 ft x 6.6 ft doors, one at the southern end of the east wall and the other at the northern end of the west wall. Both doors open at the level of the raised subfloor. The enclosure has five 46 inch x 70 inch windows made of 3/16 inch polycarbonate, reinforced with two sets of horizontal braces made from 5/8 inch plywood. Three smaller windows, nominal 1 ft x 1 ft, are located along the southern and western walls.

An area 20 ft x 26 ft was covered with additional floor tiles on top of the plastic covering. The cabinet containing the fuel array was placed upon these tiles. In addition to the cabinet containing the fuel array, three other data processing equipment cabinets were arranged on the partial layer of floor tiles. These cabinets had been gutted prior to placement in the chamber and were not operational. Three file cabinets, two tables and chairs, and a non-operating PC were also arranged in this area.

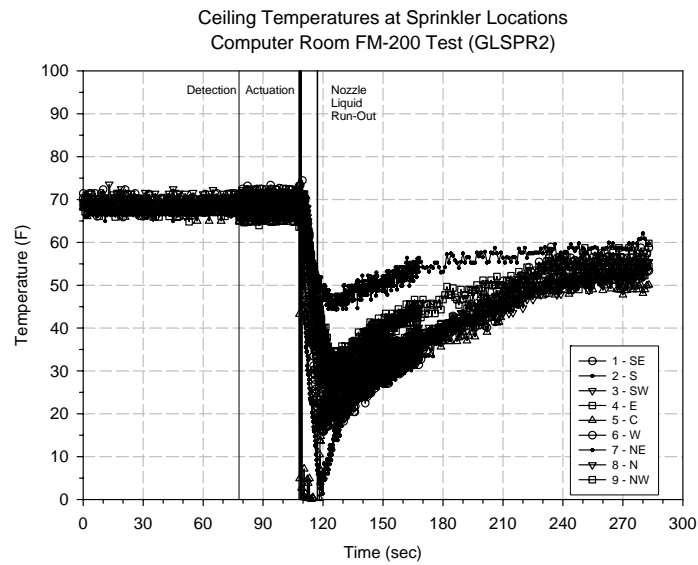
**Figure 3. Ceiling Temperatures at Sprinkler Heads: FM-200 System Test**

As can be seen from Figure 3, the ceiling temperatures at the sprinkler locations never reached more than 75 °F. Figure 4 shows that the maximum ceiling temperature observed in the enclosure was less than 85 °F.

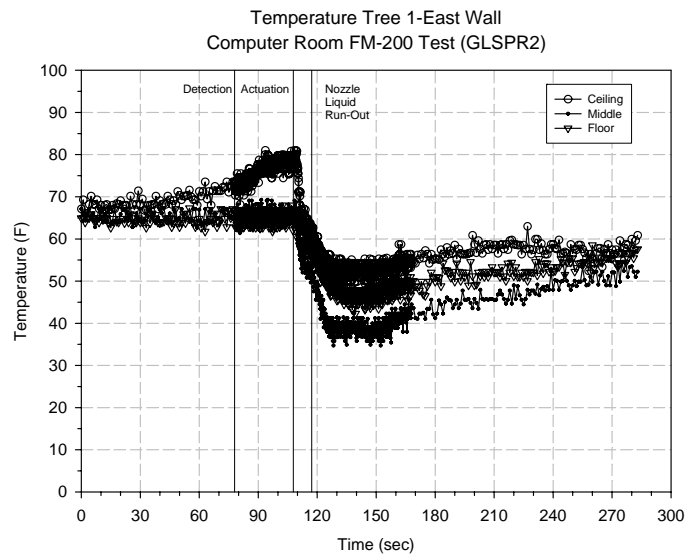
**Figure 4. Enclosure Temperatures During FM-200 System Test**

In the FM-200<sup>®</sup> test, the AnaLASER air sampling smoke detection system went into full alarm at 78 seconds after fuel ignition, and the FM-200<sup>®</sup> system was actuated 30 seconds later; from Figure 4, the fire size at the time of activation of the system can be estimated to be approximately 25 kW. The fire was observed to be completely extinguished 17 seconds after system actuation.

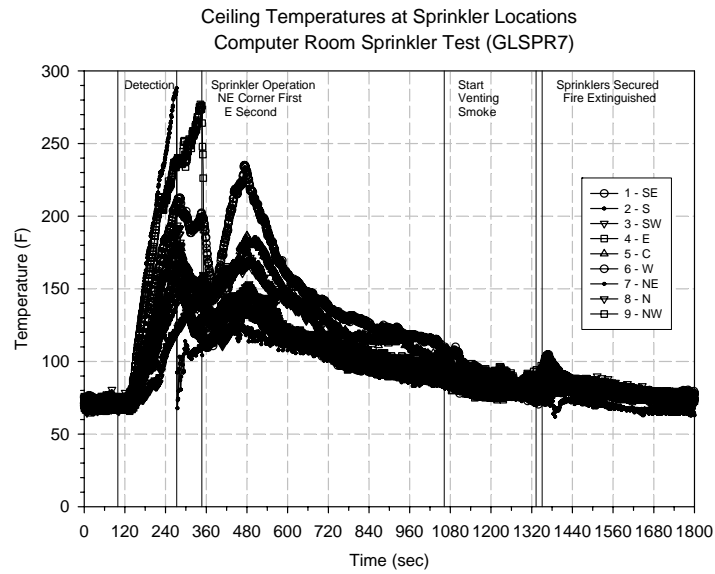
**Figure 5. Ceiling Temperatures at Sprinkler Heads: Preaction System**

As seen in Figures 5 and 6, at all locations with the exception of the southwest sprinkler, ceiling temperatures at the time of system actuation were above the 155 °F temperature rating of the sprinkler heads. However, only the northeast and east sprinkler locations got hot enough and remained hot for a sufficient time to cause activation. The east wall thermocouple tree was closest to the fire, and the ceiling level thermocouple on this tree peaked at a temperature of 560 °F at 480 seconds after ignition.

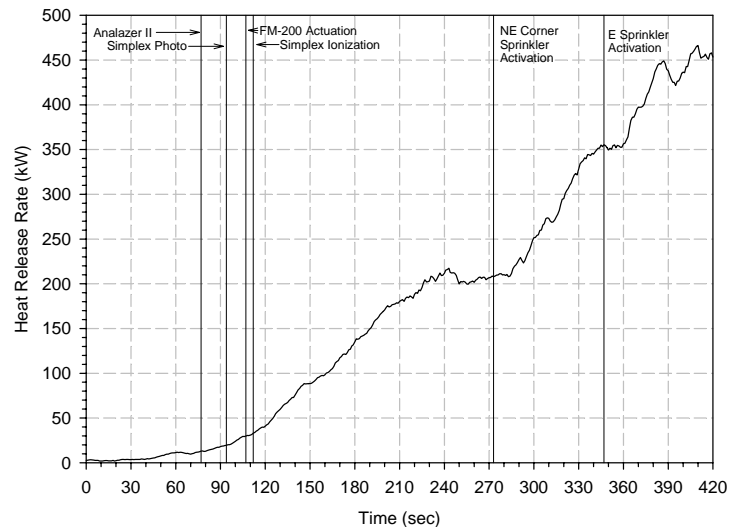
**Figure 7. Comparison of FM-200 and Preaction Systems**

The test results obtained during this study clearly demonstrate the vast differences in protection provided by gaseous clean agent and automatic sprinkler systems. Both systems, designed and installed in accordance with the appropriate NFPA standards, performed exactly as expected based upon the primary design objective of the systems. Table 1 and Figure 7 provide a comparison of the test results.

Fire Size of ABS Array used in GLCC Sprinkler Comparison Tests

Table 2 summarizes the characteristics of gaseous clean agent and automatic sprinkler systems. The fundamental objective of the two systems is vastly different. The primary objective of an automatic sprinkler system is fire *control*: confining of the fire to the room of origin and controlling the ceiling temperatures to prevent structural damage and/or collapse. This is vastly different from the primary objective of a clean agent system, which is rapid fire *extinguishment*. Figure 7 presents a graphical illustration of the difference between the two systems with respect to the heat release rate over time.
